**Complaint to National Contact Point
for the OECD Guidelines
for Multinational Enterprises**

The Samsung Heavy Industries Martin Linge Project Crane Accident Workers Support Team

II. Overview of the Martin Linge Project Crane Accident

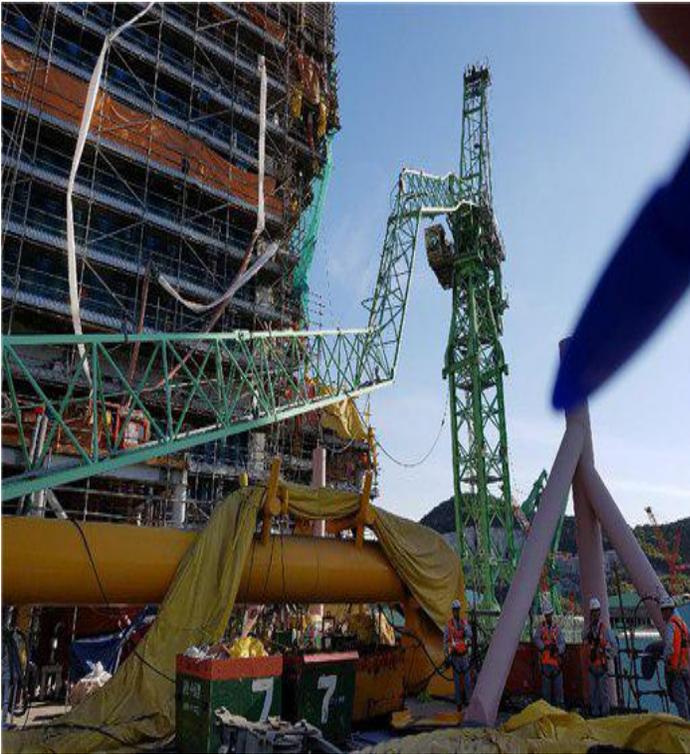
Picture of the accident (Source: Korean Ministry of Employment Labor and Press Release)

On May 1, 2017 at around 14:50 pm at Pier 7 of the Geoje Shipyard, the site of the Martin Linge module project as well as the work area of Respondent 1, a Goliath crane (800 tons) moved from the south to the north in an attempt to transport elevators from one side of the module to the other. The tie bar of a jib crane (32 tons) hit the girder of the Goliath crane. The collision caused the wire rope of the jib crane to break and the wire rope as well as the main jib fell to the main deck below causing death and serious injuries to the workers positioned there. In particular, the wire rope and main jib fell in an area often frequented by workers as there were a number of portable restrooms and a smoking area there.

At the time of the accident, the goliath crane was moving along its rails from the south to the north carrying elevators installed on the east side of the module. At that time the jib crane was carrying the trash bin to the main deck of the Martin

Linge process module and untangling its lines. If the Goliath crane were to want to cross into the jib crane work area, the jib crane must lower its roughing jib. On the day of the accident, the Goliath crane travelled successfully across the jib crane working area a total of five times. During the sixth approach, the jib crane had failed to lower its roughing jib which in turn caused the roughing jib to collide with the Goliath crane.⁴

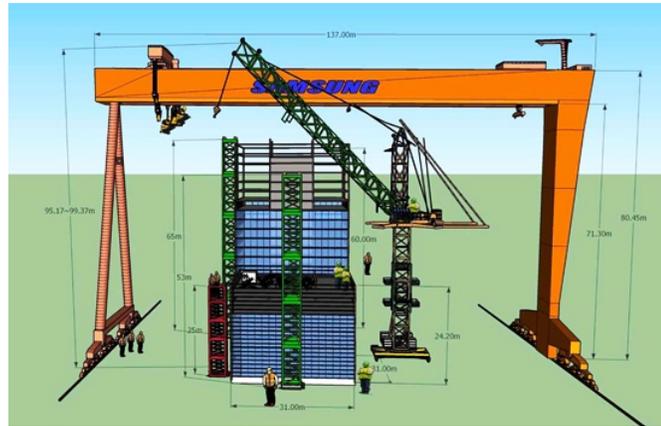
Goliath crane (from left to right) and jib crane (center) overlapping each other and interfering with each other (Source: Official Document of Korea Geoje Police)

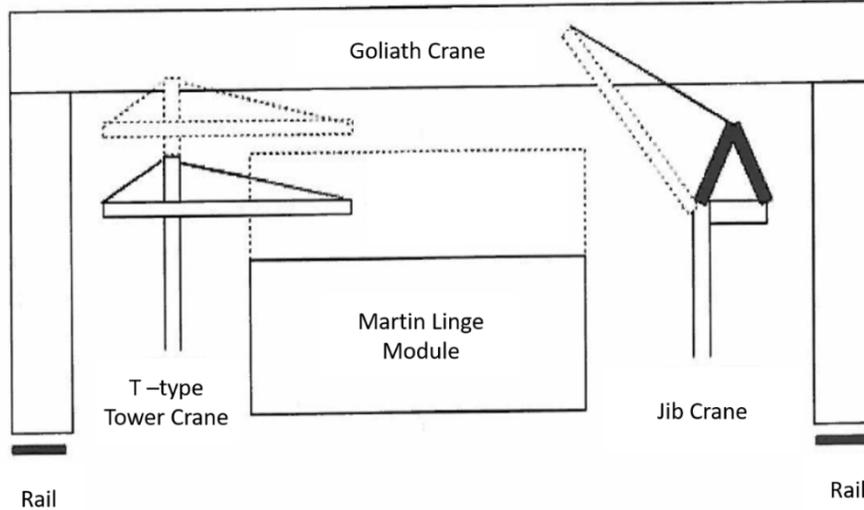
Comparison of Goliath T-type tower crane and a jib crane (Source: Appendix 2)

As shown in the image above, in order to work on the upper part of the module, the height of the T-type tower crane should be higher than the module itself but lower than the height of the lower-girder of the Goliath crane. However, in this case, it was impossible to use a T-type tower crane because of prospective interference with the Goliath crane. In order to solve this issue, the representatives of the project conducted 5-7 rounds of meetings and on their May 13, 2016, meeting ultimately decided to utilize a jib crane. On June 13, 2016, a jib crane was installed on at the Pier 7 workplace and operated until the accident occurred.

According to this work method, when the boom of the jib crane is lowered, it is safely lower than the lower girder of the Goliath crane. Yet, if the boom of the jib crane is raised, it sits higher than the lower girder of the Goliath crane. (See the above picture)

Yet, this method of work is highly unusual and dangerous. The height of the jib crane was 67.5 meters excluding the boom. Since the lower part of the Goliath crane sat at 71.3 meters high, this left only a free space of 3.8 meters high for the cranes to operate. Thus, it was only possible for the Goliath crane to pass through the jib crane area when the jib crane's boom was lower than 15 degrees. Accordingly, in order to allow the Goliath crane to pass back and forth, a very unconventional method of work was utilized that required alterations of standard work procedures as well as procedures surrounding the lowering of the jib crane and its boom.
